SHIPS' SAFETY BULLETIN

JANUARY-MARCH 2011

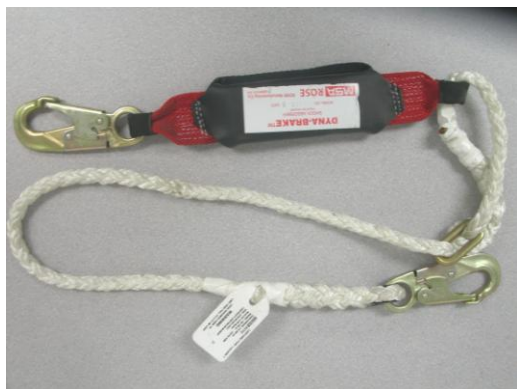
This is the old dyna-brake shock absorbing safety lanyard, MSA – Rose model 501195. It is no longer available in the stock system; but, if you still have them in your inventory they are

authorized provided they pass S-1R of PMS MIP 6231/002. This is the only authorized lanyard under NSN 4240-00-022-2521. If you ordered safety lanyards under this NSN and received anything else, you need to submit a Quality Deficiency Report through your ship's supply department.

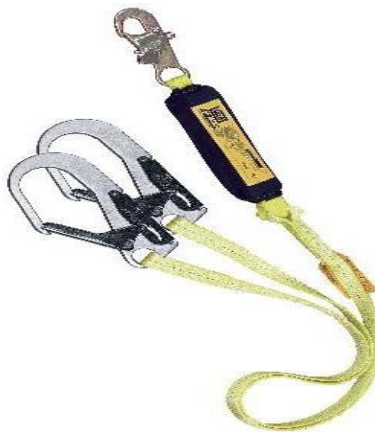
This is the twin leg big hook "Y" lanyard. It is authorized for use with unmodified climber sleeves and is only authorized for ascending and descending the vertical ladders. Once personnel transition from the vertical ladder to the platform, they must tie off to an anchor staple with a small hook lanyard. Once all climber sleeves have been modified

the big hook “Y” lanyards are to be destroyed. These big hook ‘Y’ lanyards were authorized by ISE advisory 029-07 (NAVSSS Philadelphia 171205Z MAY 07 - PASEP)

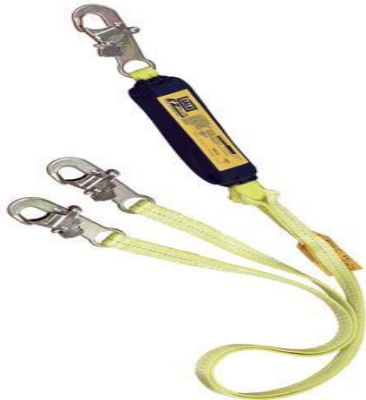
This is the twin leg small hook “Y” lanyard. This is the style of lanyard that all forces afloat should be utilizing.

All of the lanyards approved for forces afloat have a breathable cover over the dyna brake. Should you receive any from supply that have plastic or another non- breathable material, submit a QDR and turn it in to your supply department. ISE advisory 029-07 authorized the following safety lanyards for all forces afloat:

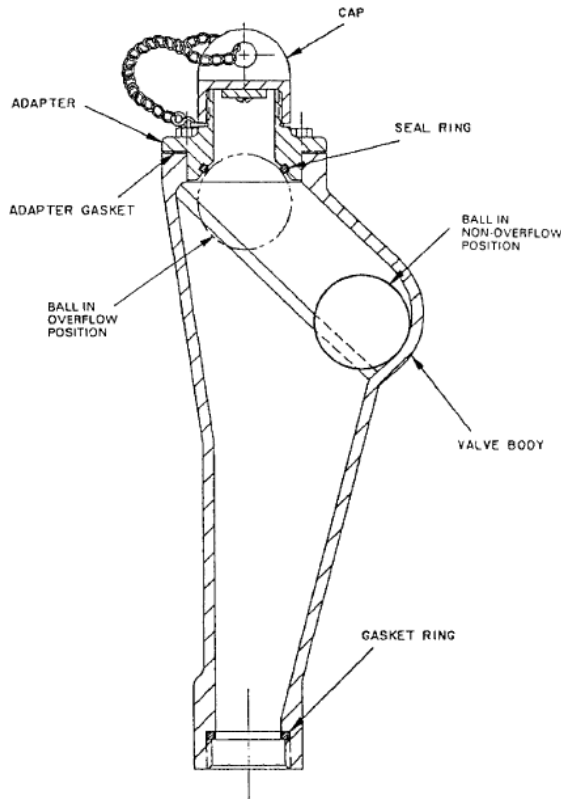
Floating ball check valve NSN

Most common discrepancies noted during safety surveys are:

- The cap is missing or improperly installed.
- The ball has been removed from the valve body.

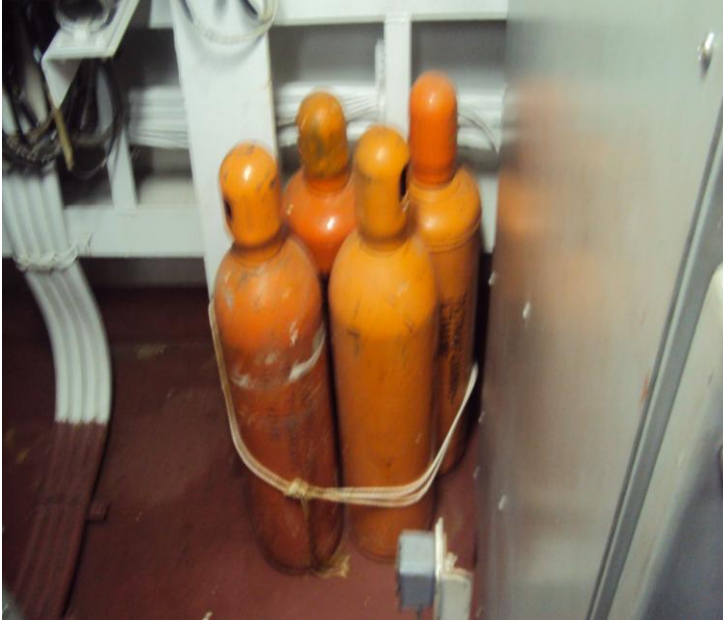
What is wrong with this picture? You guessed it; no grade “B” shock mounts for these bottles. Racks fitted with metal collars, for gas cylinders shall be similar to drawing, NAVSEA 5184287 REV A, modified to stow cylinders with minor variations in diameter. Cylinders shall be stowed with valve end up and with caps screwed in place. Stowage shall permit the removal of any cylinder without disturbing other cylinders. Cylinder stowage shall meet grade B shock. Cylinders of acetylene, cyclopropane, ethylene, hydrogen, non-liquid petroleum, liquefied petroleum (butane and propane), and other flammable or explosive gases shall be stowed on weather decks unless a gas cylinder storeroom (flammable) is provided.
